DENISE DUFFY & ASSOCIATES, INC.

MEMORANDUM

RE: Arborist Report to Obtain a Supplemental Tree Removal Permit for The Dunes on Monterey Bay Project, Phase 2 East – Evaluation Area 3

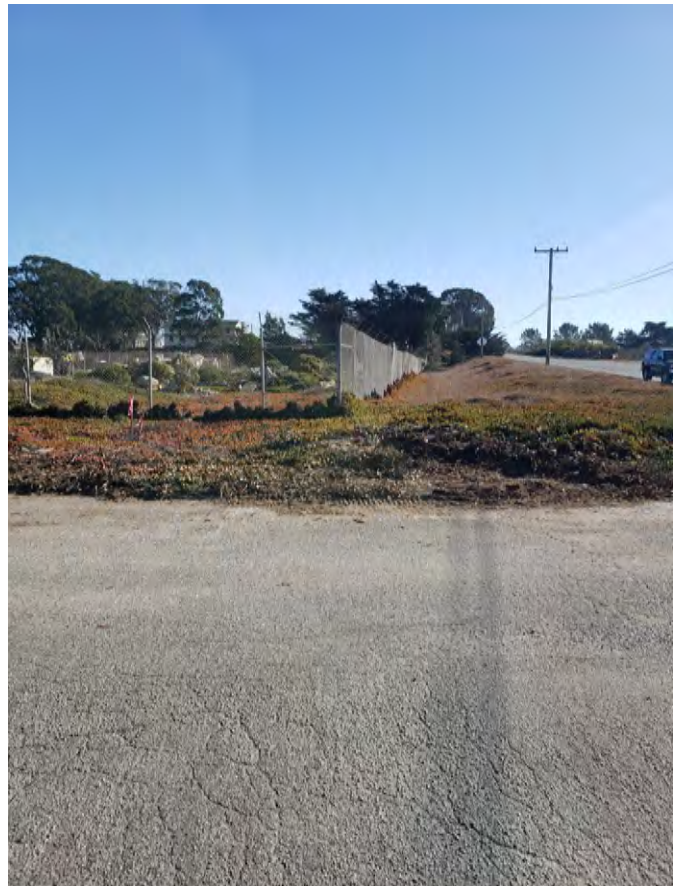
Tree 555. Monterey Cypress (removed prior to data collection)

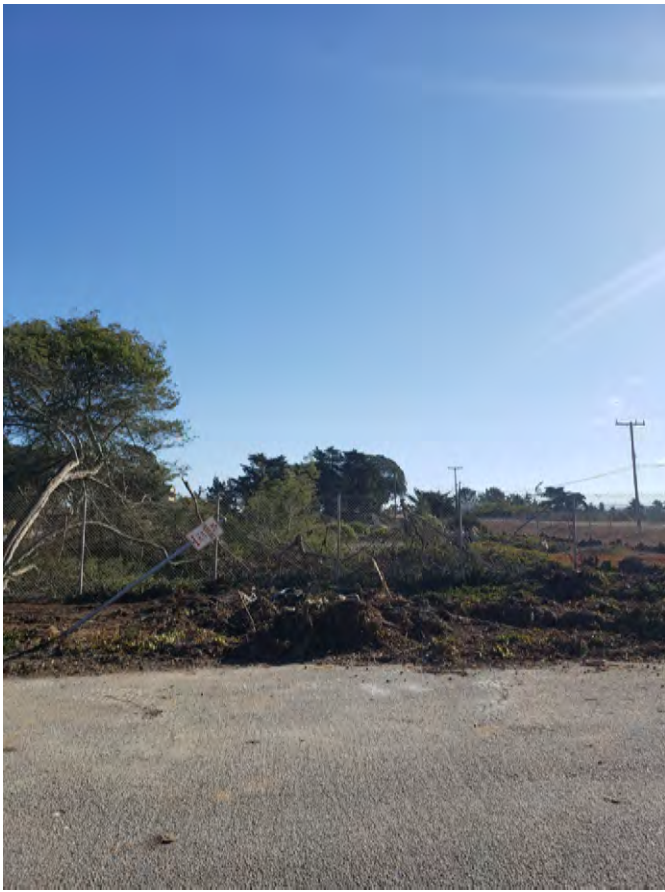
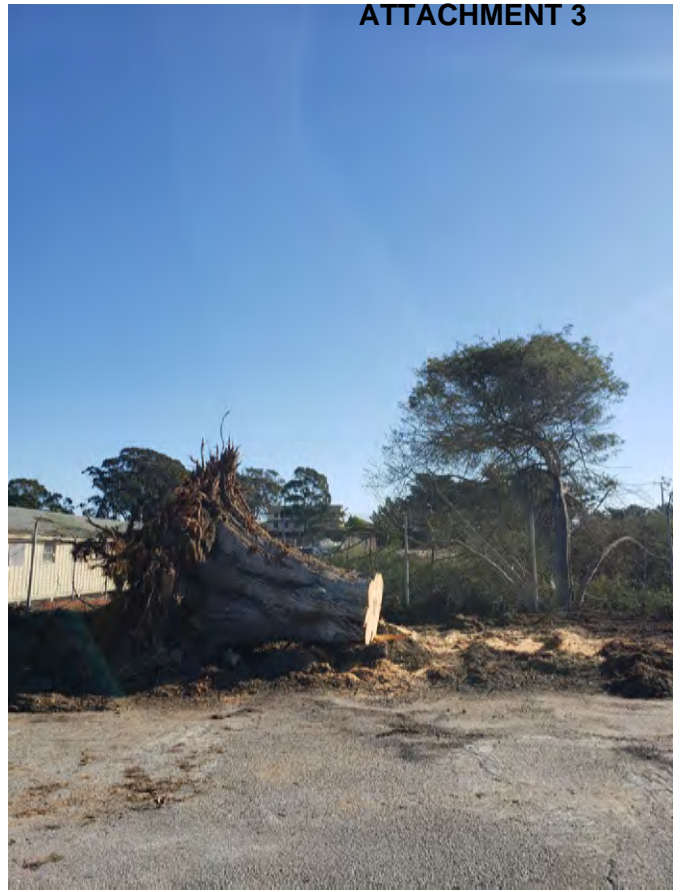
Tree 556. Monterey Cypress (removed prior to data collection) Tree 557. Monterey Cypress (removed prior to data collection)
